Case Study

In recent years there has been development of arthroscopic instrumentation that has enabled orthopaedic surgeons to do some shoulder repairs through smaller incisions. Rotator cuff repairs, labrum repair, and distal clavicle excision are a few examples of techniques that can be done through an all arthroscopic approach.

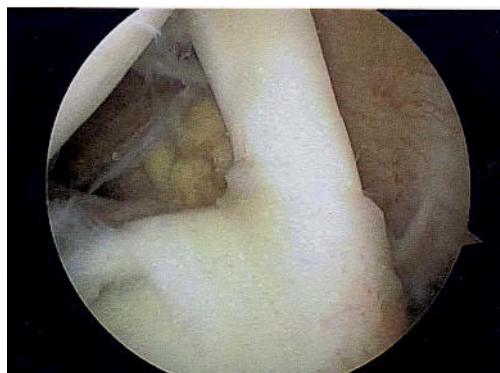
Lateral decubitus position.

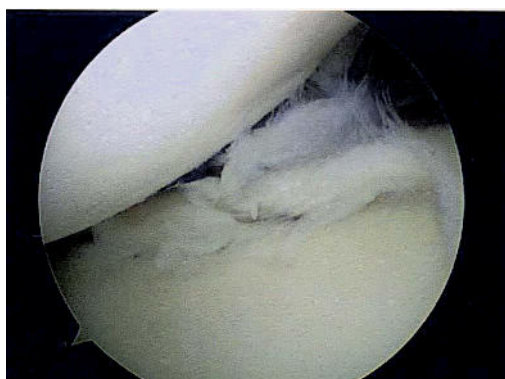
Anterior superior labrum tear.

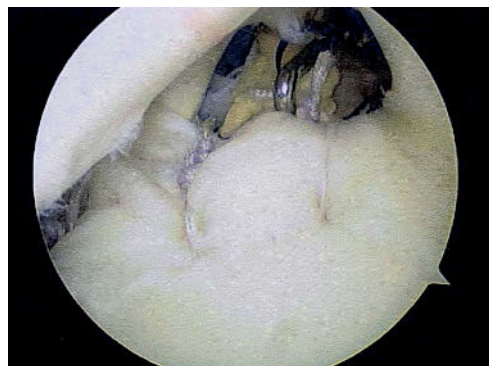
Placement of bioabsorbable suture anchors into the glenoid. Suture is tied with standard sliding knots.

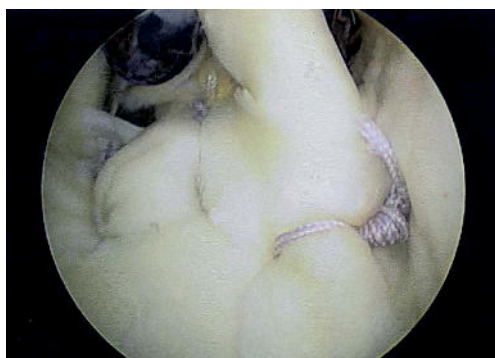
Final result. Labrum is now secured back to the glenoid with three anchors.

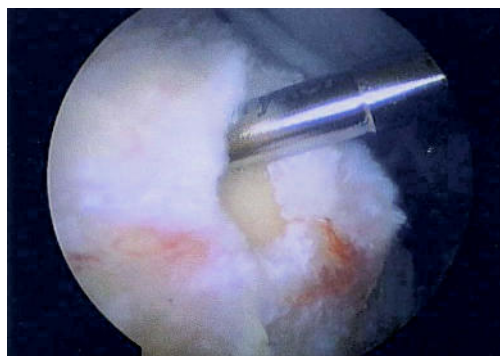
Full thickness elliptical tear of supraspinatus.

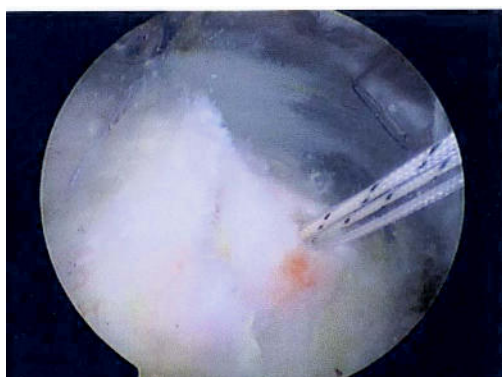
Placement of bioabsorbable suture anchors in the humerus.

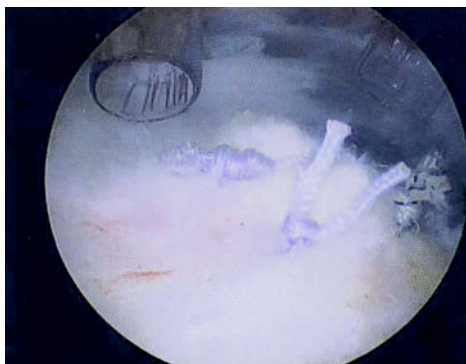
Repaired tendon secured with arthroscopic sliding knots in double row fixation.

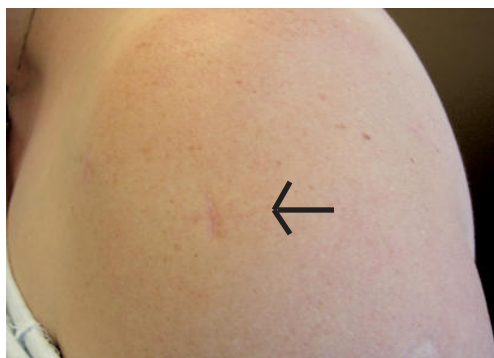
Healed incisions. Total of three incisions, each 1 cm long.

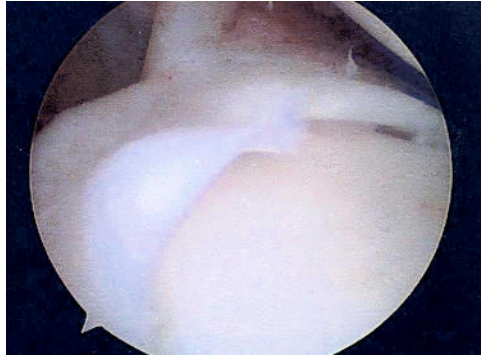
Superior/anterior labrum tear. Patient in lateral decubitus position.

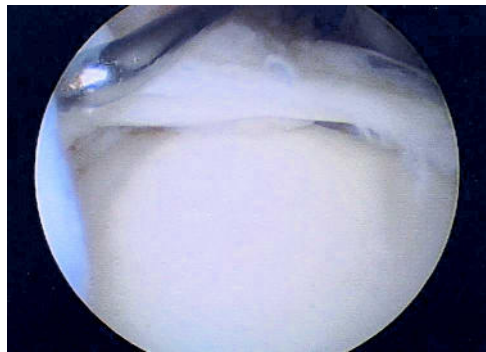
Instability of the labrum shown with probing.

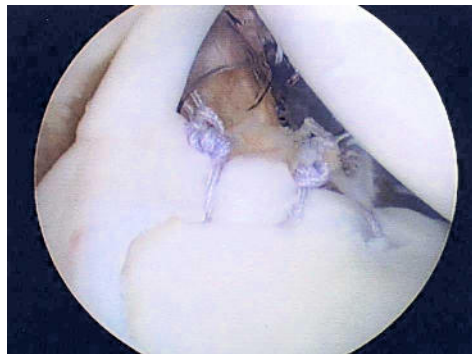
Bioabsorbable suture anchors placed in the glenoid. The labrum and capsule are secured with standard sliding knots.

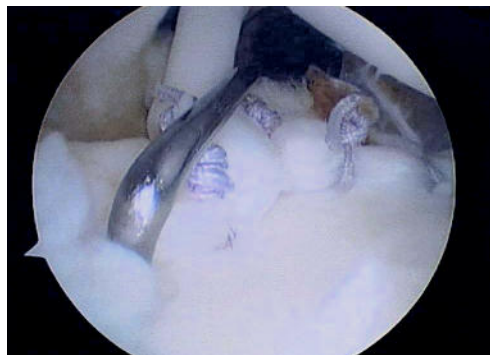
Final results with the labrum/capsule secured back to the glenoid now stable with probing.
